The fire characteristics of the Municipal noise absorbing screen

Z Mašková¹ and O Bret¹

¹ Czech Technical University in Prague, Faculty of Civil Engineering, Department of Railway Structures, Czech Republic

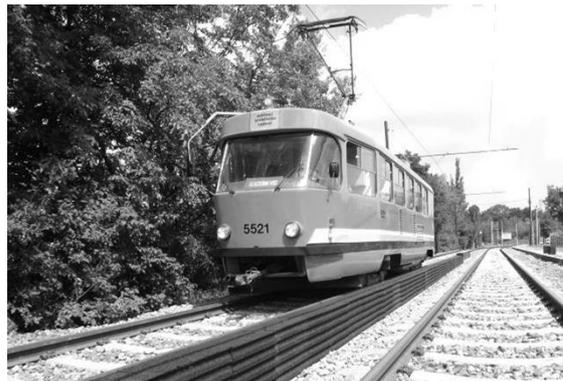
Figure 2. The Municipal noise absorbing screen in Prague – Braník.

The main material component of the Municipal noise absorbing screen is a cemented rubber granulate emerging from recycling of eliminated tyres. Within the recycling process the tyres are freed from bead wires, other metals and textile. [1] [4] The final product – granulate of a given grain size is then bonded with high-molecular-weight polyurethane adhesive and placed into individual manufacturing forms. These forms are adjustable so various surface finishes can be achieved (e.g. waves, pyramids, etc.). These surface finishes help to a better acoustic absorption of the screen. [4] Figure 2 shows the design used in the test section in Prague – Hloubětín which was realized in 2018.

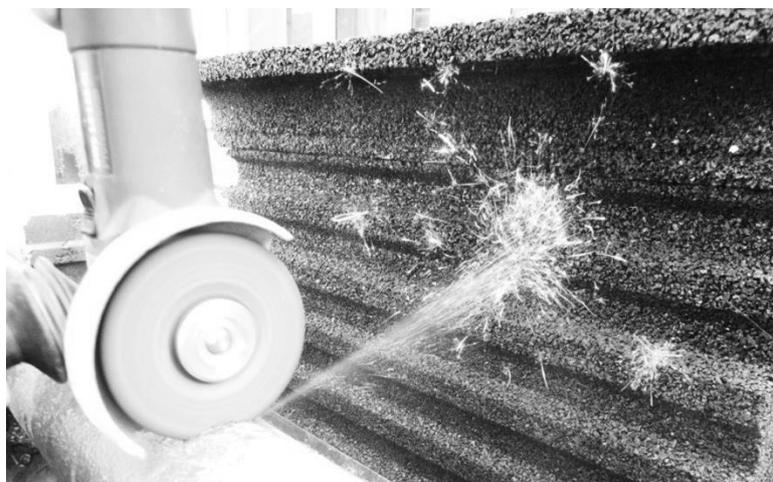
Figure 3. Test 1 - simulating rail grinding.

3.2.1. Test 1 – Effect of fly away sparks simulating rail grinding. The aim of this test was a determination of segment's reaction on effect of sparks as a simulation of rail grinding. There were two takes within this test where a tube from cast iron was placed on a metal frame in two different distances from the segment. The first distance represented the actual distance from the screen's face to the track, or more precisely to the outer rail. The second configuration should provide bigger amount of fly away sparks coming to a more concentrated area on the face of the screen. The entire construction was secured against shifting. The tube was cut with an angle grinder so that the sparks flew away to the face of the screen (Figure 3). These sparks should simulate the state during rail grinding. In both cases, the segment was exposed to the sparks for 30 s. Results from this test can be seen in Table 1.

Conclusion: The risk of a flare from the fly away sparks is negligible. The effect of the fly away sparks caused a local increase of temperature by approximately 10°C. During rail grinding the screen is under supervision when the workers can immediately intervene in the case of potentially problematic situation (e.g. occurrence of fire or its expansion).
